“DETERMINATION OF LANDSLIDES AND FAULTS IN THE TRANSMISSION LINE CARIBLANCO-SAN MIGUEL, COSTA RICA 2009”

A. Gómez ^{a*}, C. Sanchez ^{b*}, F. Borrego ^b, J. Bonatti ^{c*}, L. Saenz ^{d *}, M. Martinez ^b

The unstable and geologically hazardous area of Poas Volcano (Costa Rica) was affected by a 6.2-degree magnitude earthquake in January of 2009. The consequences of the earthquake were shocking. The urban area of Cinchona was almost devastated and its residents are being relocated. Road links were severely damaged, major landslides blocked them for many days after the earthquake.

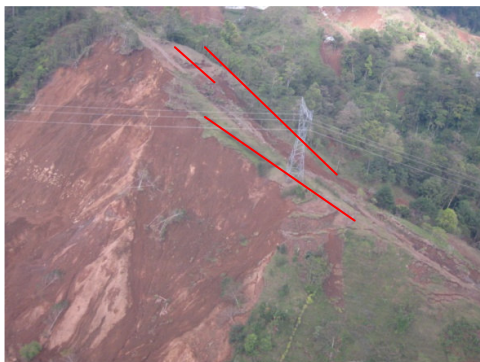
Fig.5. "NS" direction cracks. San Miguel-Cariblanco-Cinchona area

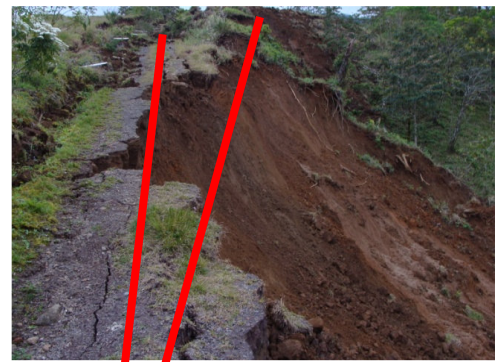
Fig. 6. "NE" direction cracks. San Miguel-Cariblanco-Cinchona area

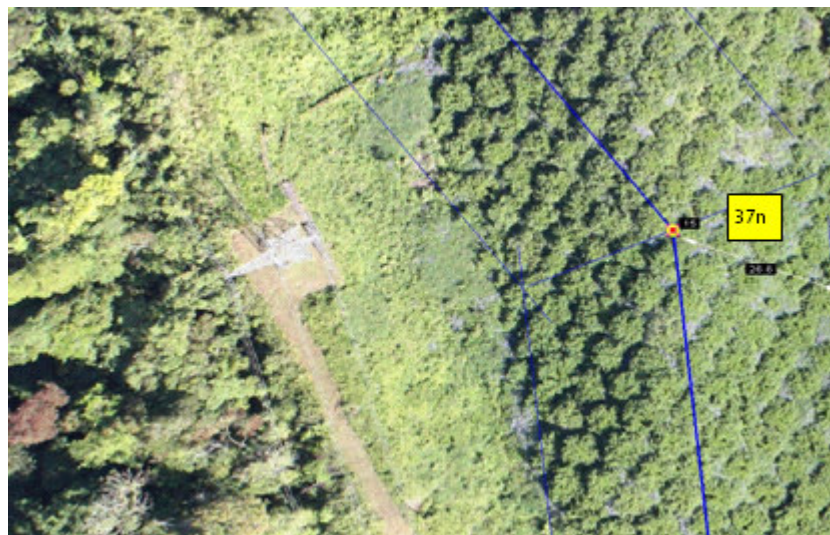
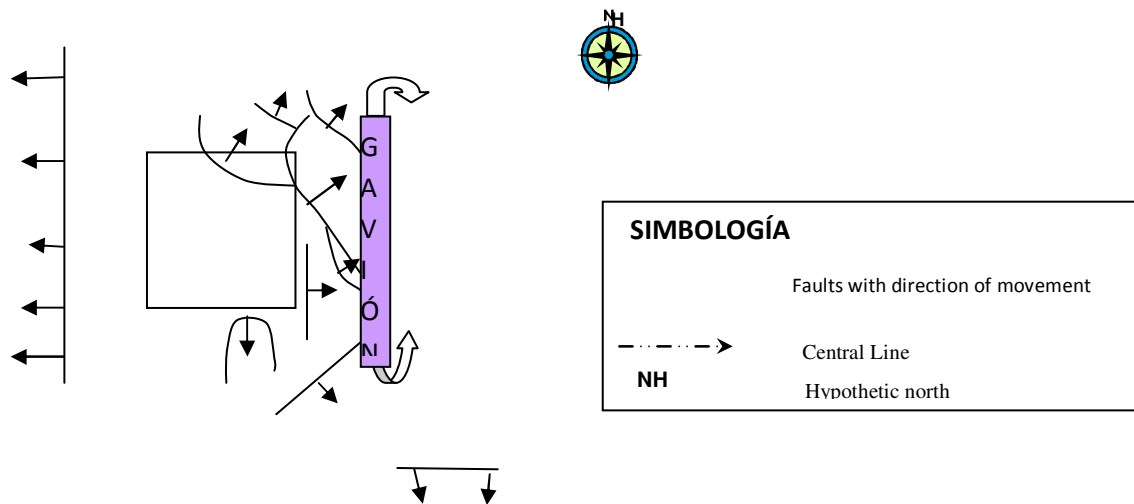
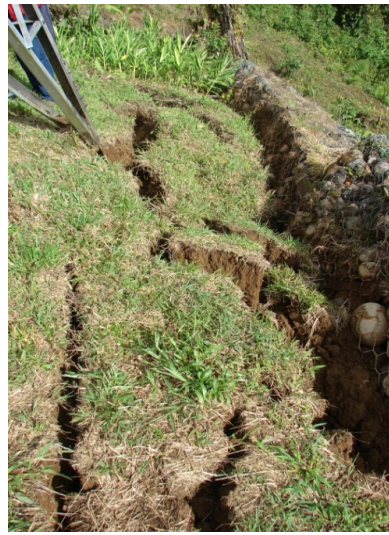
The Tower is founded on metric thickness soils that previously had problems of stability, demanding at the time the construction of protected rocks on its side that after the event collapsed and towards the West sector presents at least 5 levels of fractures that determine dowels with moving eastward and affecting the leg C. However other fractures in the way of access put at risk the West side of the structure.

The structure presented slight curvature in the amounts due to settlements and differential displacement in the legs. The vertical component these offsets vary from 10 to 15 cm. This curvature in the Tower elements fails in imminent danger of collapse to the structure.

Issues of access due to over two metres wide at the way tension cracks were detected.

Evaluation of the Tower: yellow condition

Fig.5. Tower TS 37 LT Cariblanco-San Miguel, possible site of replacement. Picture from digital camera in *LiDAR* sensor incorporated.

Fig 6. Schema's break in the Tower 37

Fig. 7- Tower 37 LT Cariblanco – San Miguel. Horizontal and vertical movement in the terrain and structure. Picture from Ing. Bayardo Selva Mora.

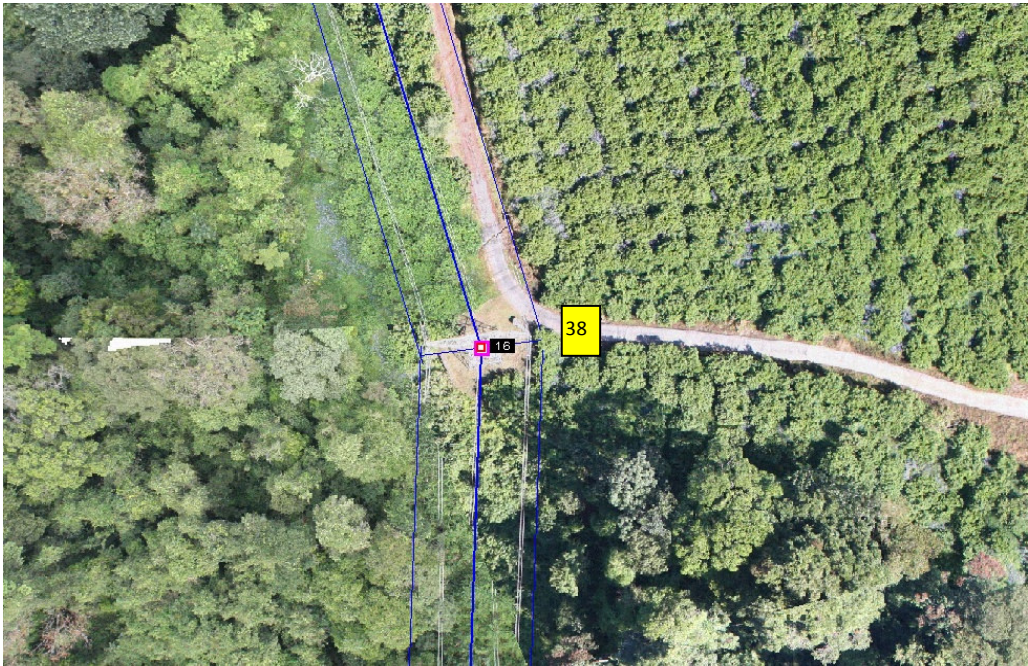
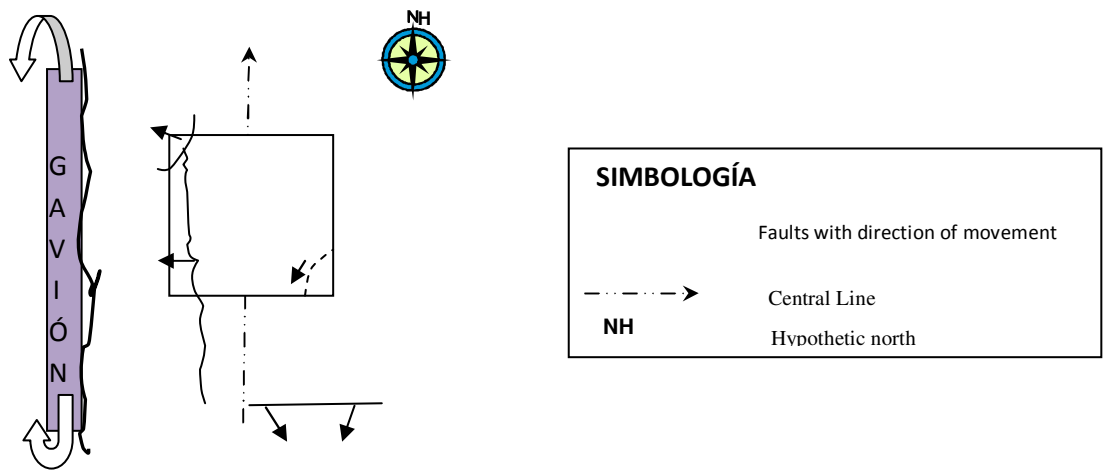
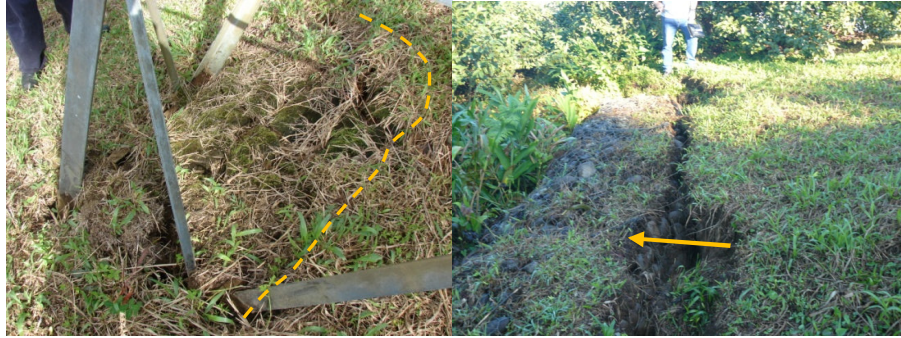
Tower TA 38

Cracks were observed during the visit to assess by specialists in Geotechnics. Problems detected by the nearby volcamiento of stones covered and because it is a structure in angle should pay you attention. The Tower not presented buckling or failure problems in any element.

Evaluation of the tower: Yellow condition.

Fig.9. Schema of fracture in the Tower 38.

Fig.10. Tower 38 LT Cariblanco-San Miguel. Note the horizontal movement in the terrain and possible fracture. Ing. Bayardo Selva Mora. Y Cristiam Valerio

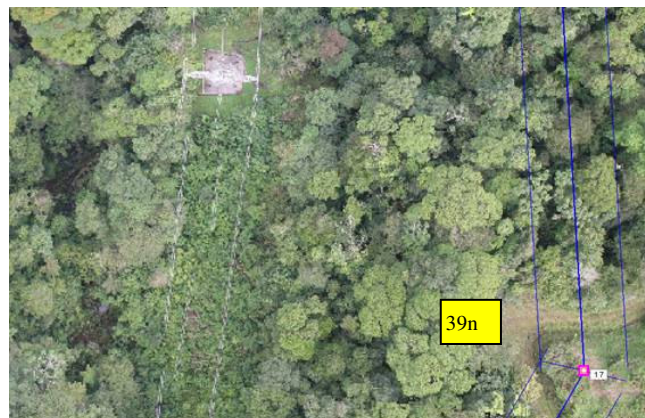
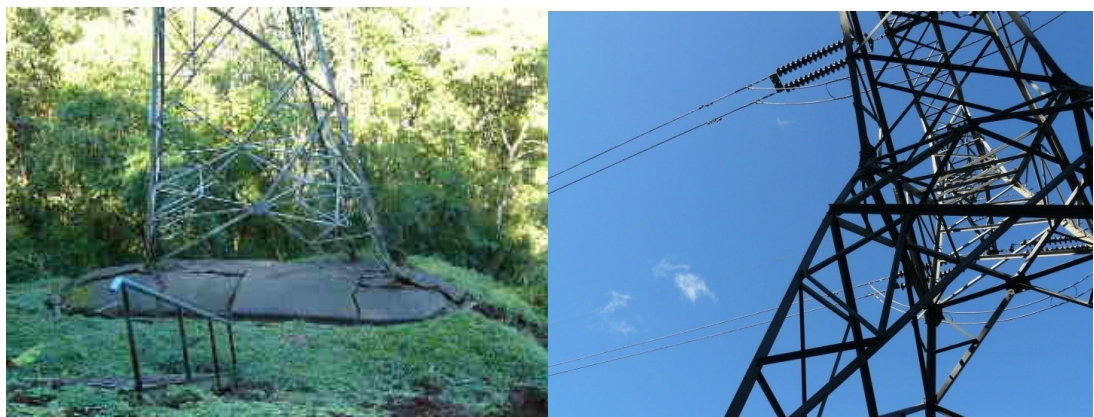
Tower TA 39

There were numerous cracks in the lining of concrete tower site that reflect the existing field and small landslides in legs oriented in the direction of Cariblanco (North).

Curvatures and important deflections had been observed.

Evaluation of the tower: Red condition.

Whereas the deterioration of sites and structures affectation, we recommend relocate the Towers 39 and 45 in the shortest time possible, to better mechanical physical condition of soils, but with slope instability sites, whereas the impossibility of better conditions in the towns, causing the recommendation to treatment of soils in the previous form pre-selected sites.

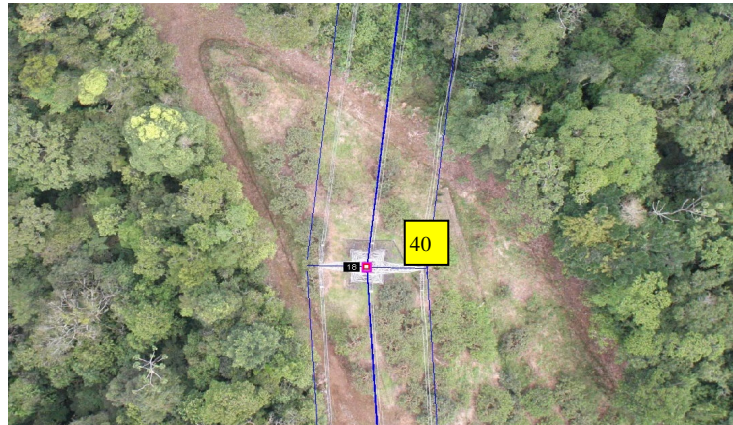
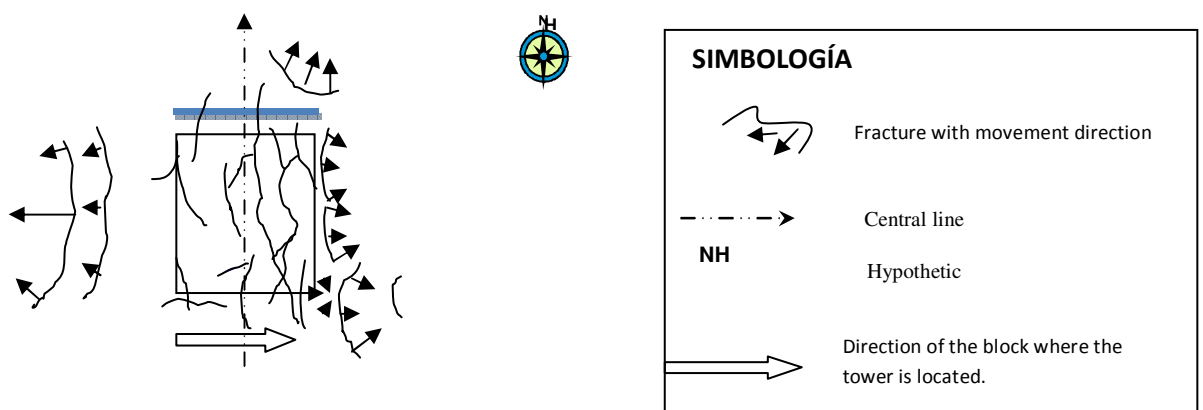
Tower TA 40

There were numerous cracks along the way before the Tower, in the area of the towers and surrounding found cracks multi-direction crossing the legs, extending to the East side with small dowel, showing the entire block where the tower knocked over.

These surface fractures have openings that vary from cm to some dm; direct measurement of its depth exceeds 1.8 m, by which the risk that fractures extend beyond the level of Foundation, this thickness based decamétrico and development of these volcanic soils.

Elements bent in the enclosure or frameworks to top-level legs were observed that demonstrate displacement and differential settlements between the legs of the tower.

These deflections in the Tower elements fail in imminent danger of collapse to the structure and provided not differential movements between the legs to increase this issue continue presenting can cope with.

Evaluation of the tower: Red condition.

Fig.13. Cracks near the legs of the TowerTower 40 LT Cariblanco-San Miguel

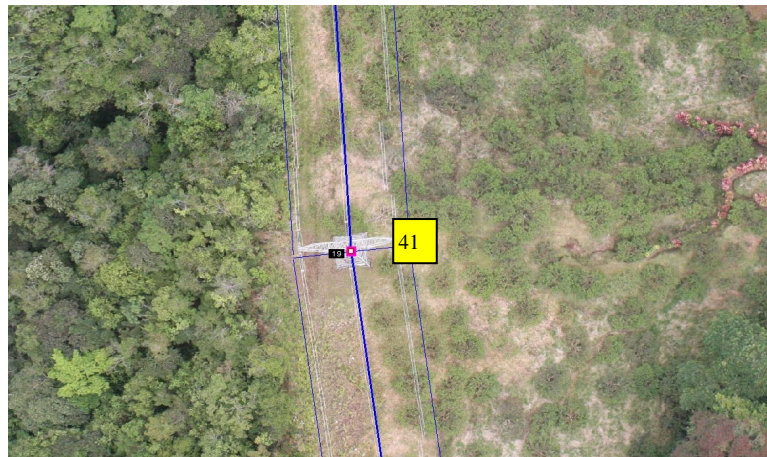
Tower TA 41

These surface fractures have openings that vary from cm to some dm; direct measurement of its depth exceeds 1.8 m, by which the risk that fractures extend beyond the level of Foundation, this thickness based decamétrico and development of these volcanic soils.

During the visit numerous cracks were observed before the tower. The site and surrounding area found cracks multi-direction. Elements bent in the enclosure or framework to top-level legs that demonstrate displacement and differential settlements between the legs of the tower were observed.

These deflections in the Tower elements fail in imminent danger of collapse to the structure and provided not differential movements between the legs to increase this issue continue presenting can cope with.

Evaluation of the tower: Red condition.

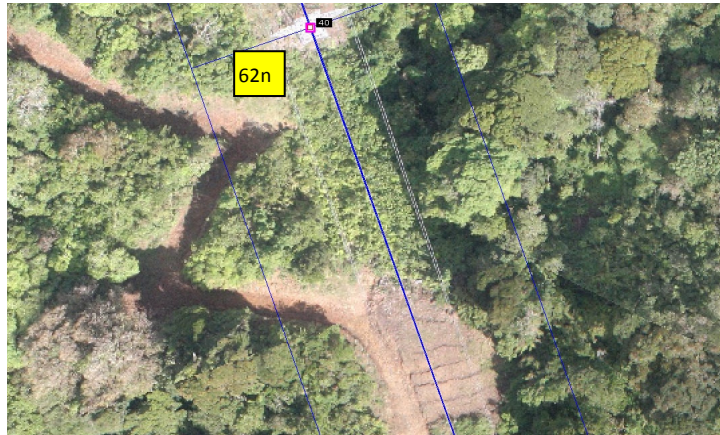
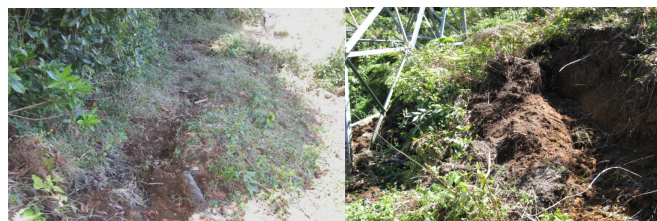
Tower TS 62

Noted that the tower is founded on soil without any anchor to rocky substrate whereas the profanity of this, previously had stability is treatment problems overcome with the placement of a gabion on the East side of the structure, which stopped working after of the earthquake and is currently dump being floating shape.

The tower site is affected by at least four major fractures and their associated fractures affect structure components either directly or by material mobilized towards them.

The parallelism between major fractures determines dowels with movement westward, featuring internally very low stability. Horizontal and vertical movements of the legs of the towers were observed. The Tower does not present any element deformations or visible inflections.

Evaluation of the tower: Red condition.

Fig.16. Fractures to the West of tower 62, obvious movement towards East, causing small landslides that put pressure on the structure. Picture from Geol. Ronald Valverde.

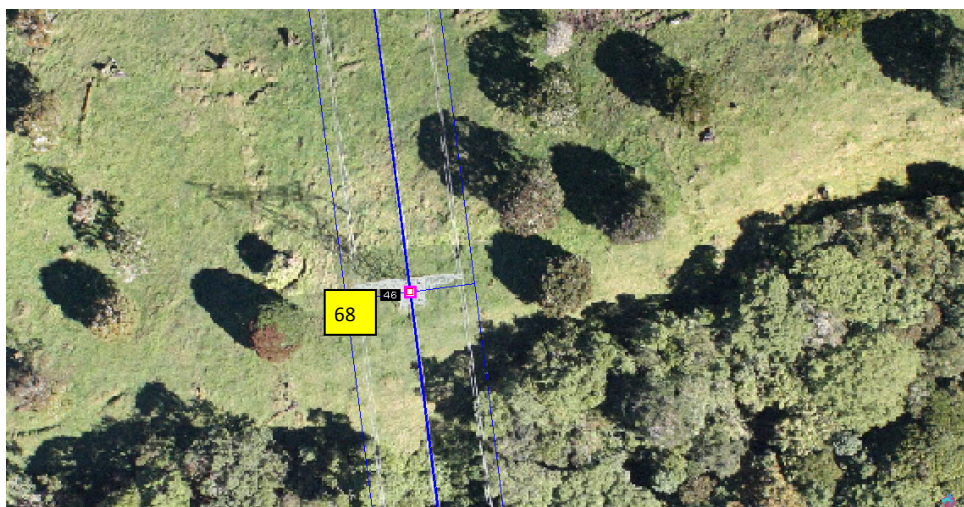
Tower TS 68

During the visit were cracks in the ground to approximately 10 m of the legs of the tower.

Evaluation of the tower: Yellow condition.

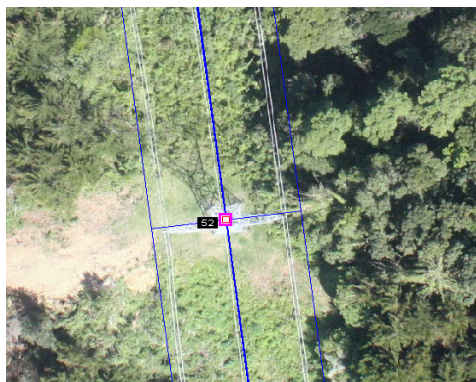
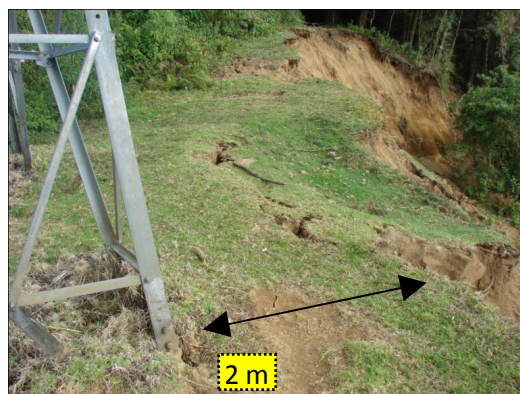
Tower TS 74

Significant cracks near the feet of the tower were observed during the visit. Ran a collapse approximately 2 m between legs A and D.

Problems of access due to significant cracks were detected.

Evaluation of the tower: Red condition.

Fig.19. Tower 74. Slope close to the tower. Picture from Ing. Bayardo Selva Mora
